**High speed wind tests  
on Ubbink Ubiflex  
Flashing system.**

Prepared for: Barry Donaghue  
of Ubbink uk Ltd

16<sup>th</sup> June 2008

Test report number 245-513

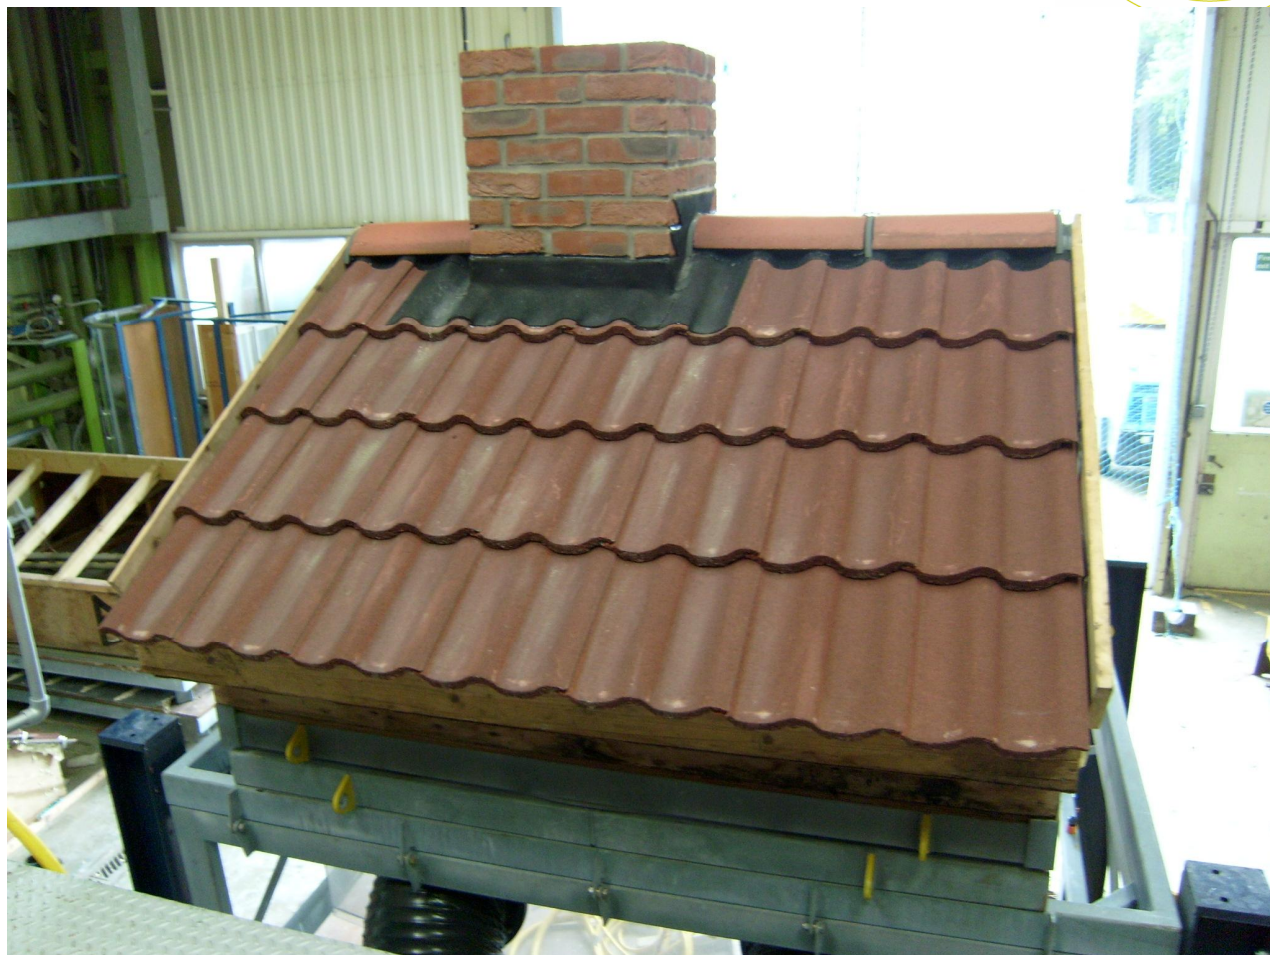
Figure 1. Side 1 Double pantiles and Ubiflex flashing around the chimney.

During testing the flashing around the chimney resisted the maximum wind speed of 49m/s (109mph) without visible damage.

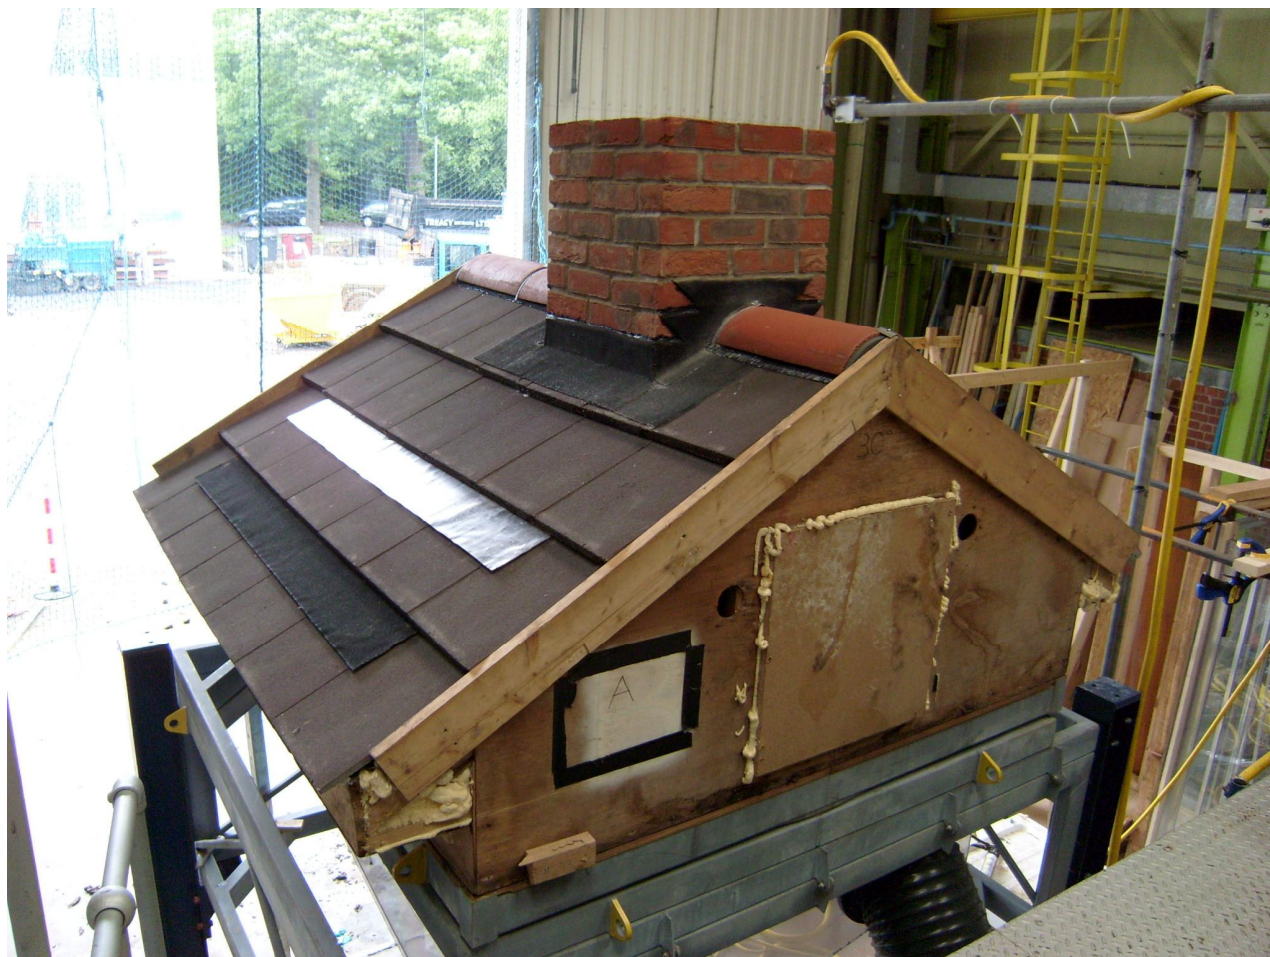
Figure 2. Side 2 Flat concrete tiles and flashing around chimney with additional flashing fitted between courses of the roof tiles.

During testing the flashing around the chimney resisted the maximum wind speed of 49m/s (110mph) without visible damage.

At an angle of 45° the unsealed Ubiflex flashing bent progressively back over the tiles as the wind speed increased the effects being more severe at the corner into the wind. The lead flashing started to lift at a wind speed of 35m/s (78mph) and this became progressively more severe as the wind speed increased. At a speed of 45m/s (101mph) the whole of the lead flashing flipped back lifting the 3<sup>rd</sup> course of tiles up to about 45° at which point they locked into position against the 4<sup>th</sup> course of tiles and remained in place.

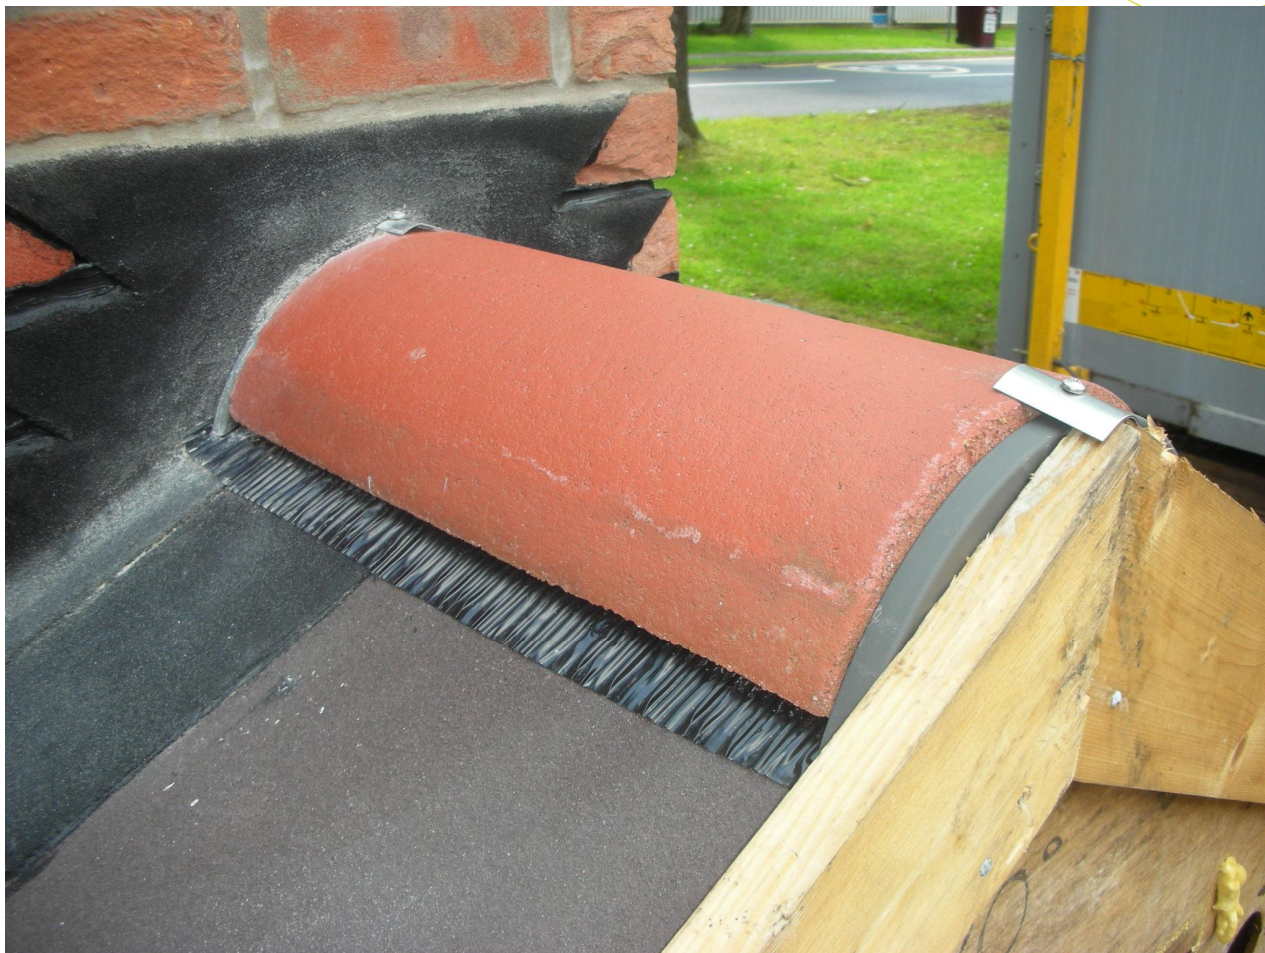
Figure 3 Side 2 showing detail of the Ubbink Ventilated Dry Ridge system

During the course of the testing described above there was no visible damage to the Ridge tiles or to the Ubbink Ventilated Dry ridge system.

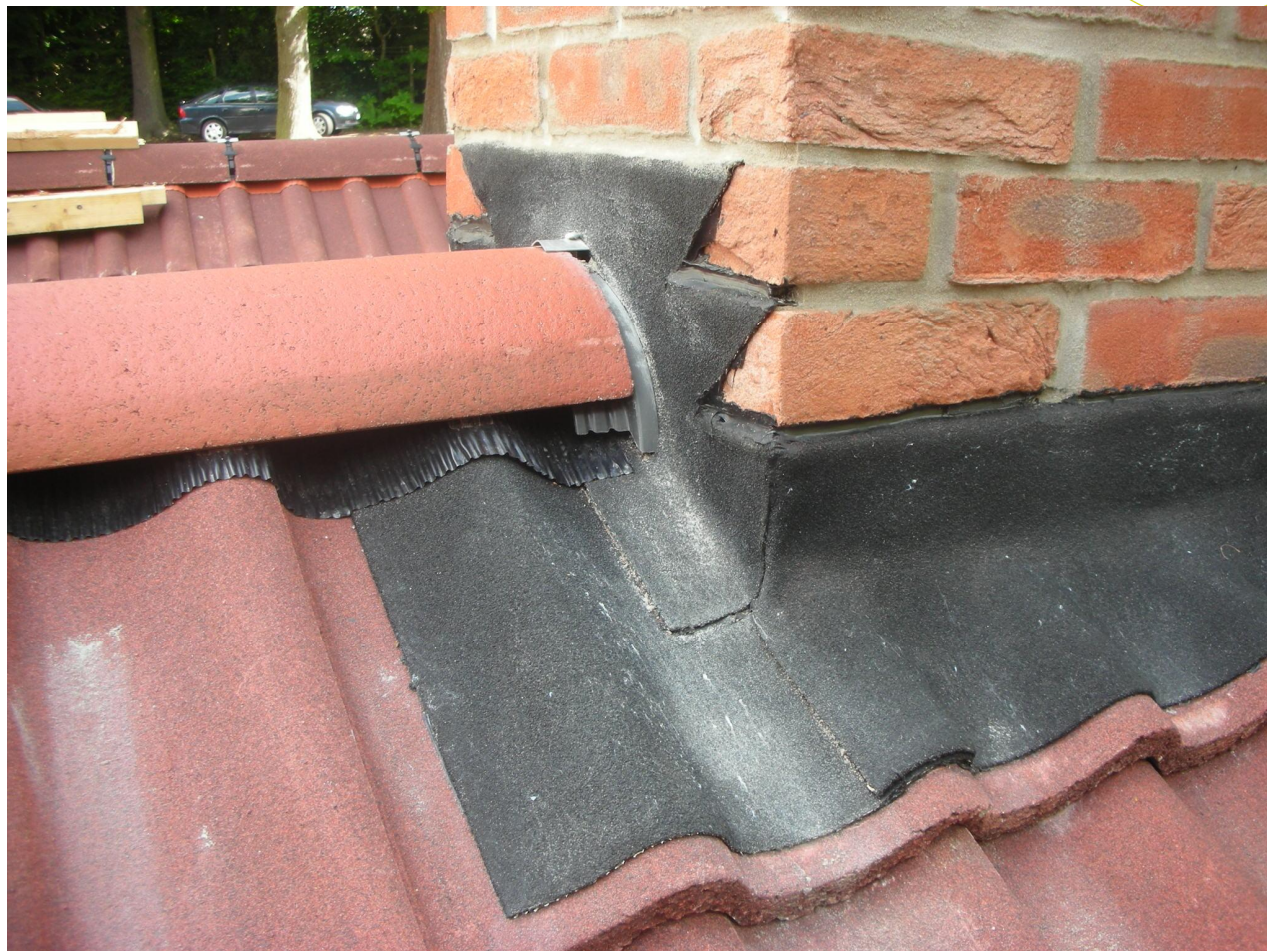
Figure 4 Side 1 showing detail of Ubbink Ventilated Dry Ridge system

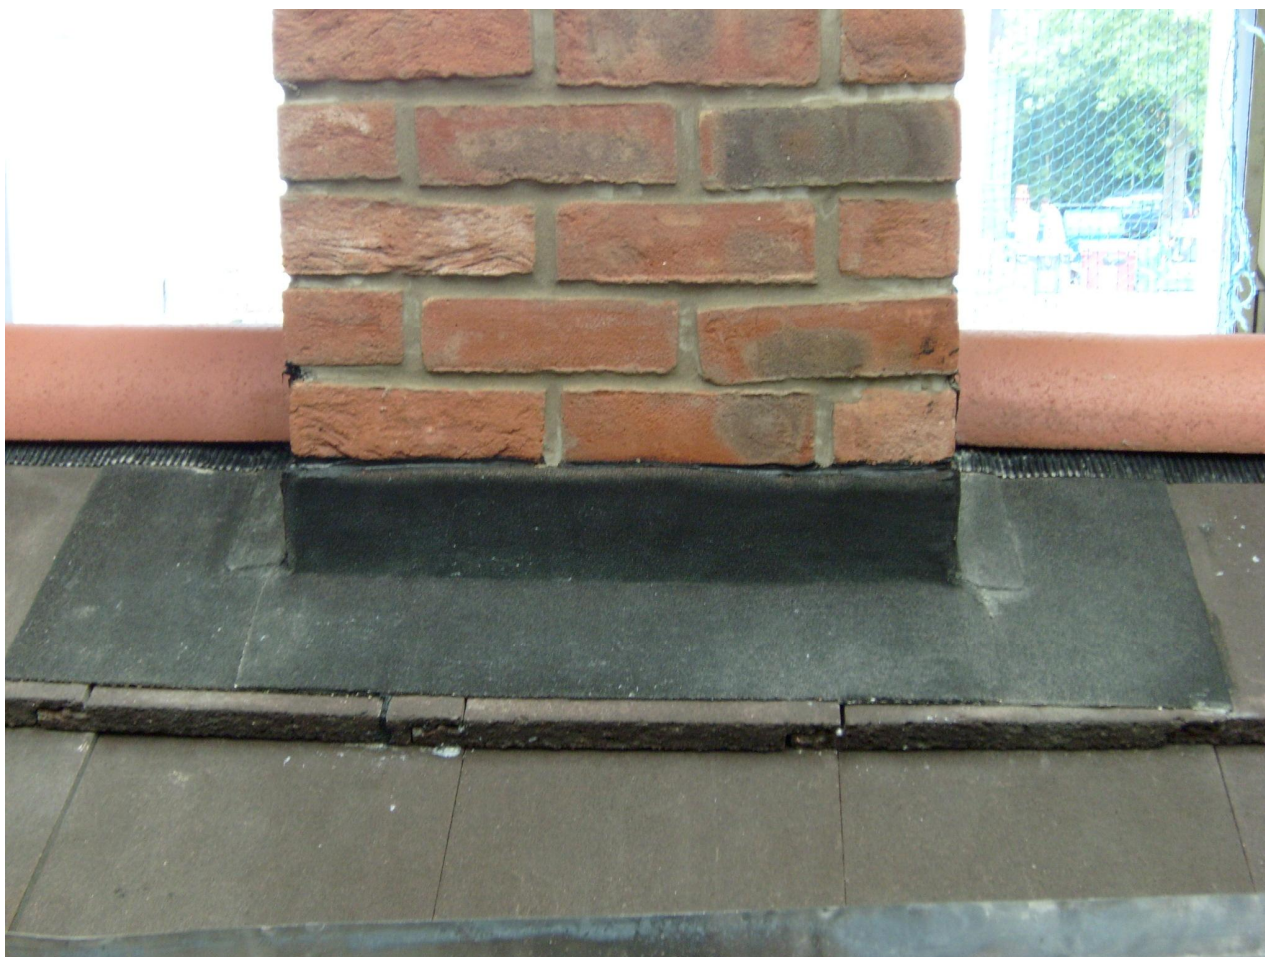
**Figure A1** side 2 showing flashing after completed test programme 45m/s (101mph)

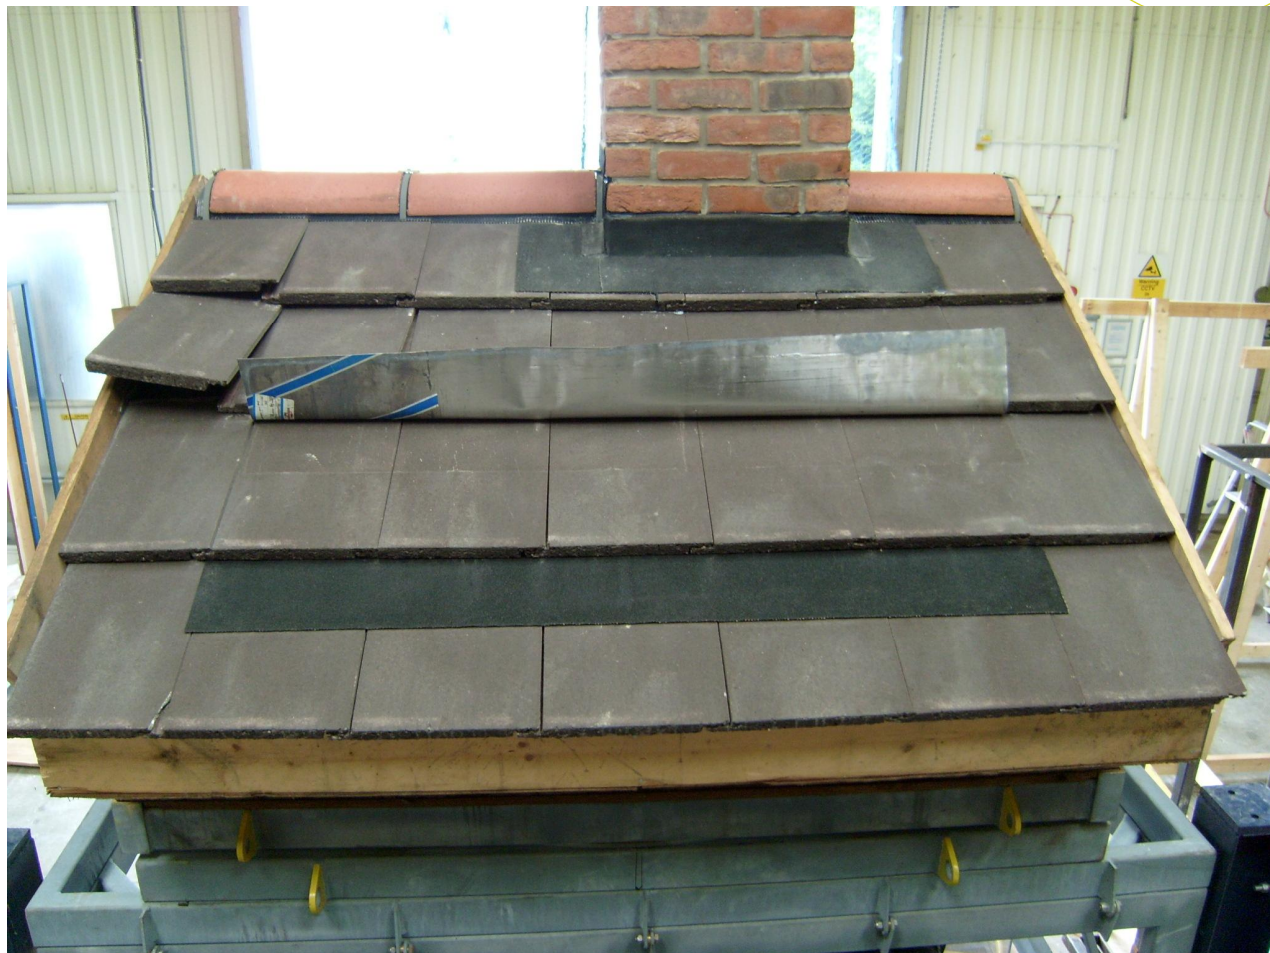
**Figure A2** side 2 after completed test programme showing damage to lead flashing and tiles 45m/s (101mph)

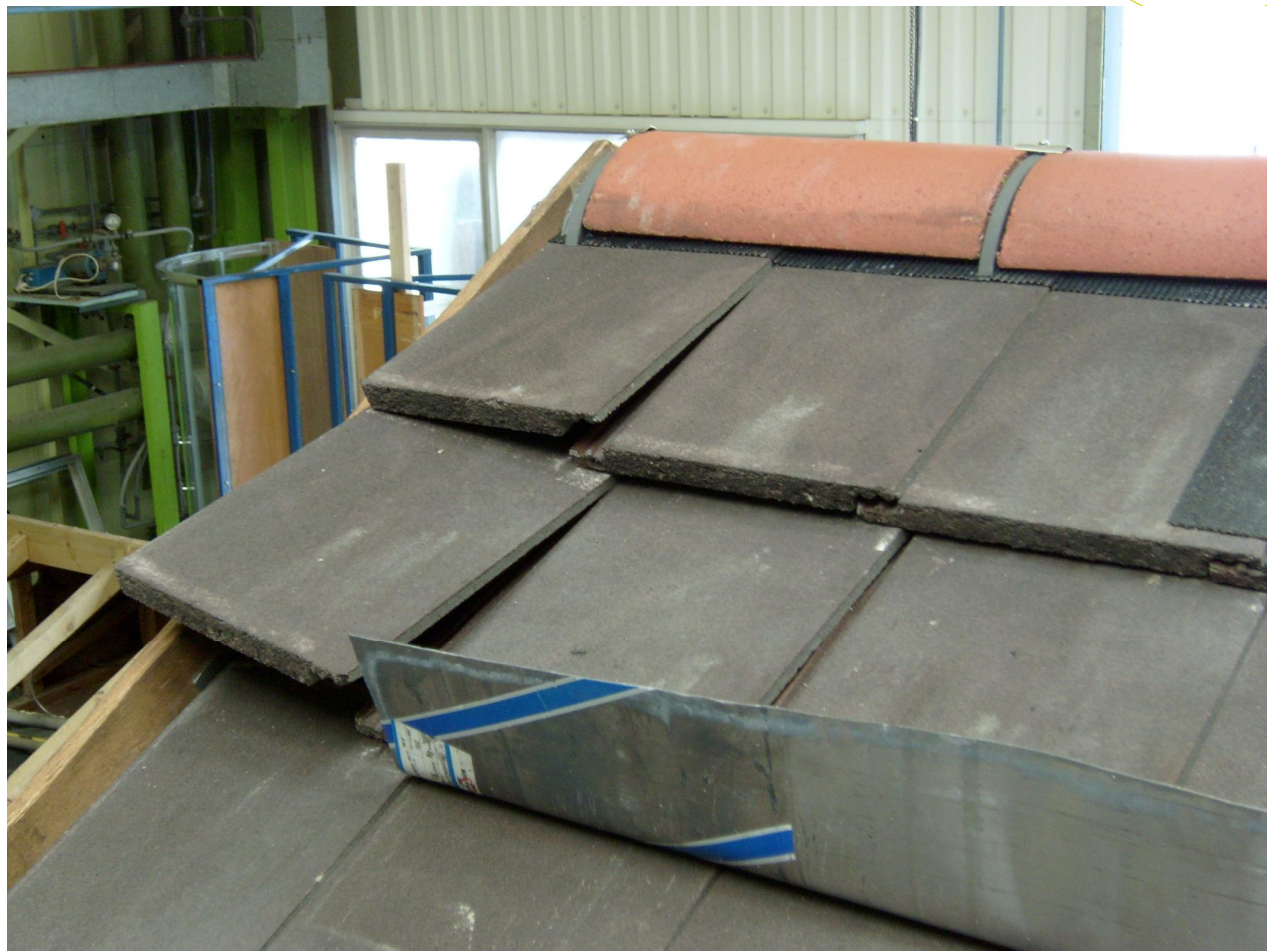
Prior to testing with the wind at 90° to the eaves the Ubiflex flashing was fixed to the roof with a strip of 15mm Ubi-Seal around the perimeter. This remained in place without any visible damage during the course of the test. During the course of the test the lead flashing lifted from the surface of the roof as the wind speed increased until at the end of the test it was bent back approximately 90° against the tiles. At 45m/s (101mph) on the left hand side of the roof the 3<sup>rd</sup> course of tiles lifted approximately 200mm but remained on the roof for the rest of the test.

**Figure A3** side 2 showing detail of damage to lead flashing and displaced tiles at a wind speed of 45m/s (101mph)
