Introduction To EcoProof

EcoProof specialises in fully bonded, liquid applied waterproof seamless systems. Our focus is to provide long lasting, high performance waterproof membranes fit for purpose.

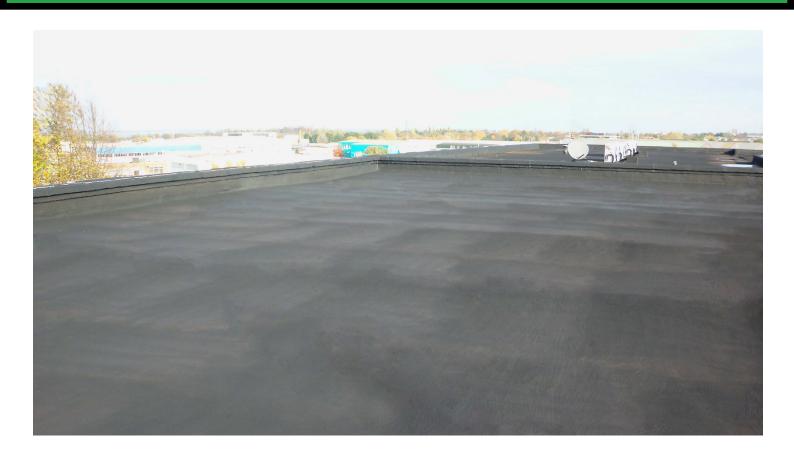
- Single-Ply Project
- Overall size 6000sq/m

CPI Mackays was a failing Single-Ply Installation with water ingress problems causing major production issues with the operations below.

The finished product was an overcoated single-ply membrane with EcoProof Roofing System leaving a completely seamless finish.

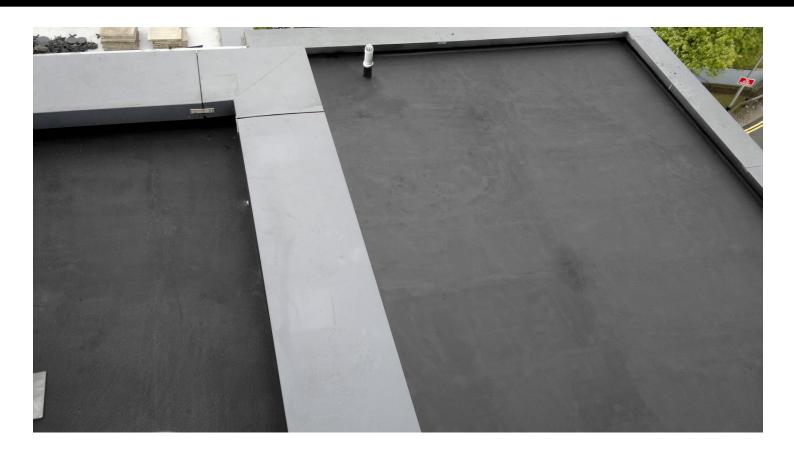
- Single-Ply Project
- Overall size 600sq/m

The Immigration Centre London was a existing Single-Ply Installation with failing joints and signs of water ingress throughout most of the detailing work.

The result was an overcoated single-ply membrane with EcoProof Roofing System leaving a completely seamless finish with repairs carried out to rectify the existing detailing using Liquid Membrane and Strengthening Tape.

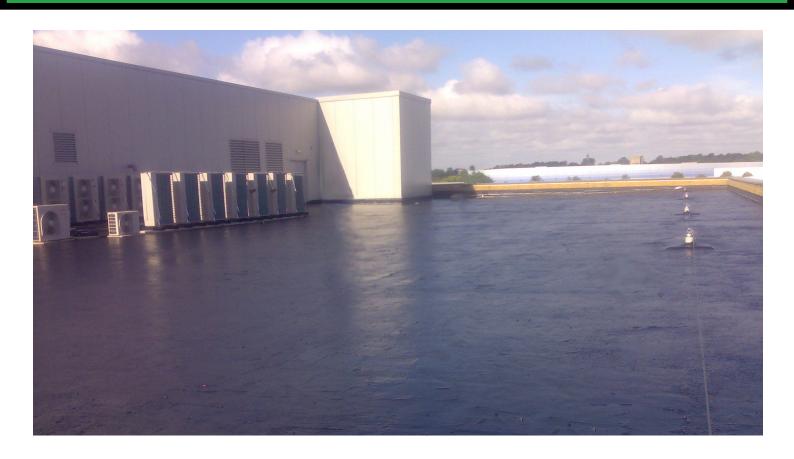
- Kodak Building
- Asphalt Project
- Overall size 2000sq/m

Following damage from the Buncefield oil explosion it was essential the Kodak building was made waterproof to avoid any further damage to machinery below.

An EcoProof Roofing System was applied to the entire area leaving a completely seamless finish with repairs carried out to rectify any damage using Liquid Membrane and Strengthening Tape.

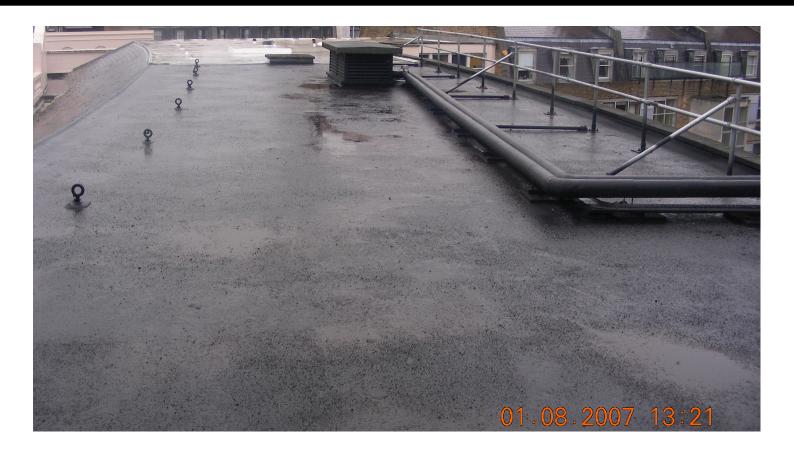
- British Medical Research Centre
- Asphalt embedded with aggregate
- Overall size 1200sq/m

The British Medical Research Centre was an asphalt project with embedded stone with multiple leaks which were attempted to be spot repaired with other systems at great cost.

The EcoProof Roofing System was specified as a cost effective, long term alternative to repairs and was used to overcoat the entire roof area.

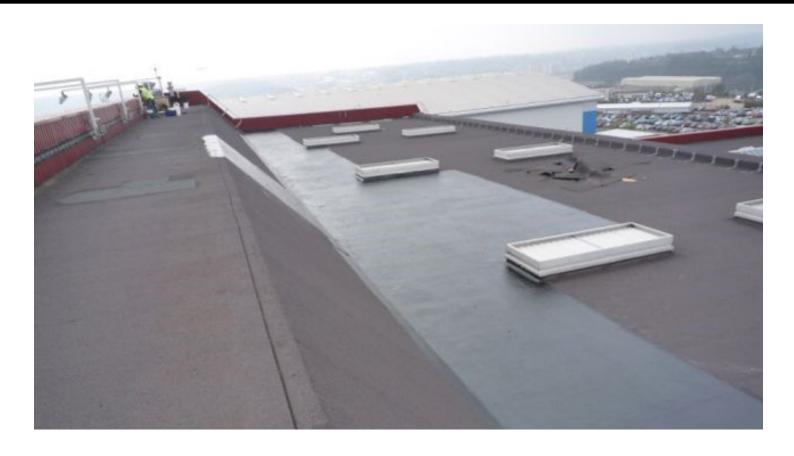
- Felt repair
- Overall size 200sq/m

When part of the felt roof at Luton Airport de-bonded from the surface EcoProof Roofing System was specified to re-bond the existing felt and overcoat the damaged area.

This resulted in a quick and effective repair avoiding any water ingress into the airport terminal.

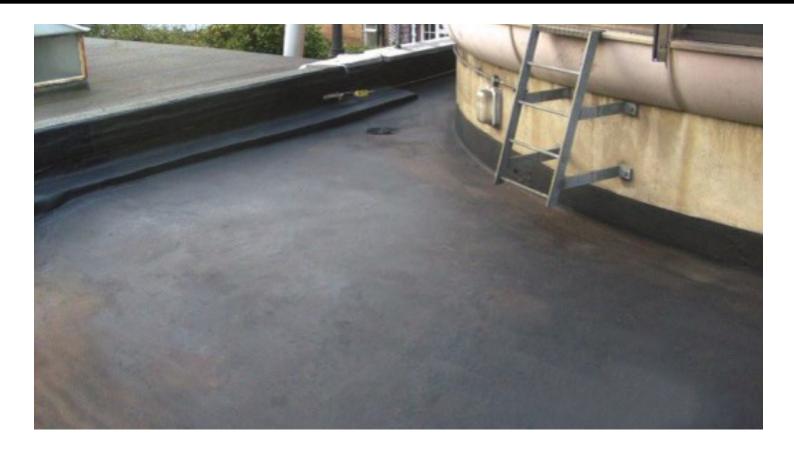
London Underground-Holland Park Station

- Felt Project
- Overall size 200sq/m

Leaks in the felt roof above Holland Park Station was the cause of delays and issues for the operations below.

The damage to the current felt covering was repaired using Liquid Membrane and Strengthening Tape and then overcoated in EcoProof Roofing System.

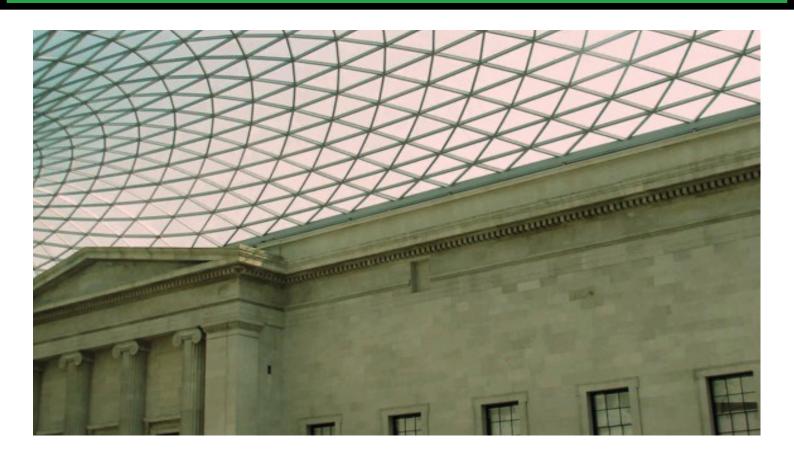
- British Museum
- Metal Project
- Overall size 1800sq/m

When the copper roof at the British Museum began to ingress water and with complex detailing around plant on the roof EcoProof was put forward as a solution.

The EcoProof Roofing System was specified on this project and was used to overcoat the copper and detail all the plant on the roof.
