Design & installation details - Robust detail FFT1, 2, 3, 4 and 5

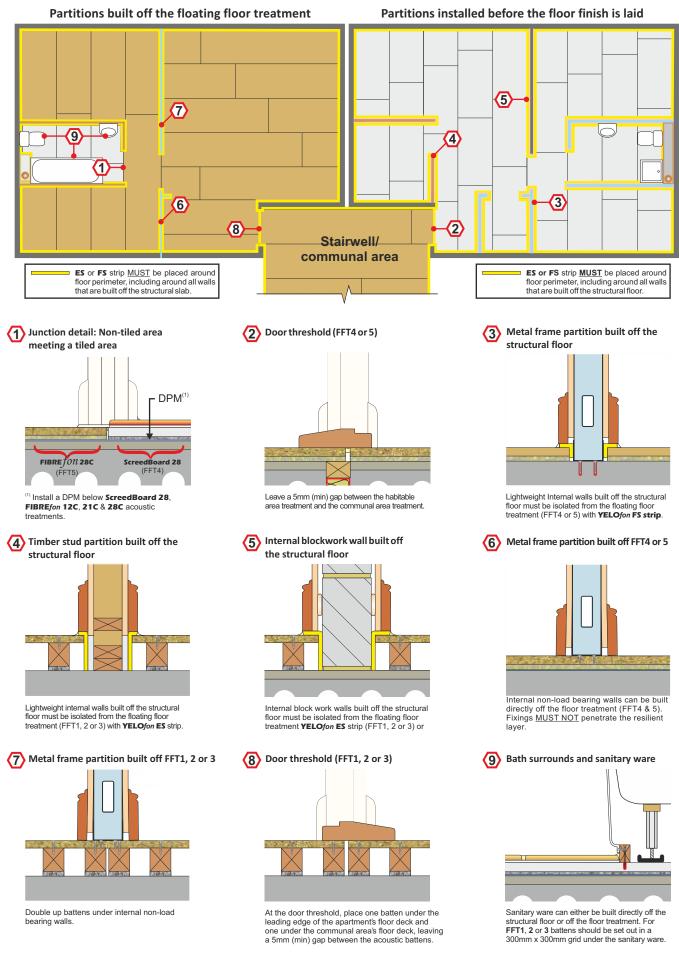
The acoustic performance of the floor will be compromised if the floating floor treatment is not completely isolated from the structural slab, soil pipes, door frames, the surrounding walls and their treatments. To address this risk, each potential problem area needs to be detailed accordingly.
